Brick Paving Systems in Expeditionary Environments: Field Testing

Haley P. Bell and Quint Mason

July 2012

Final report

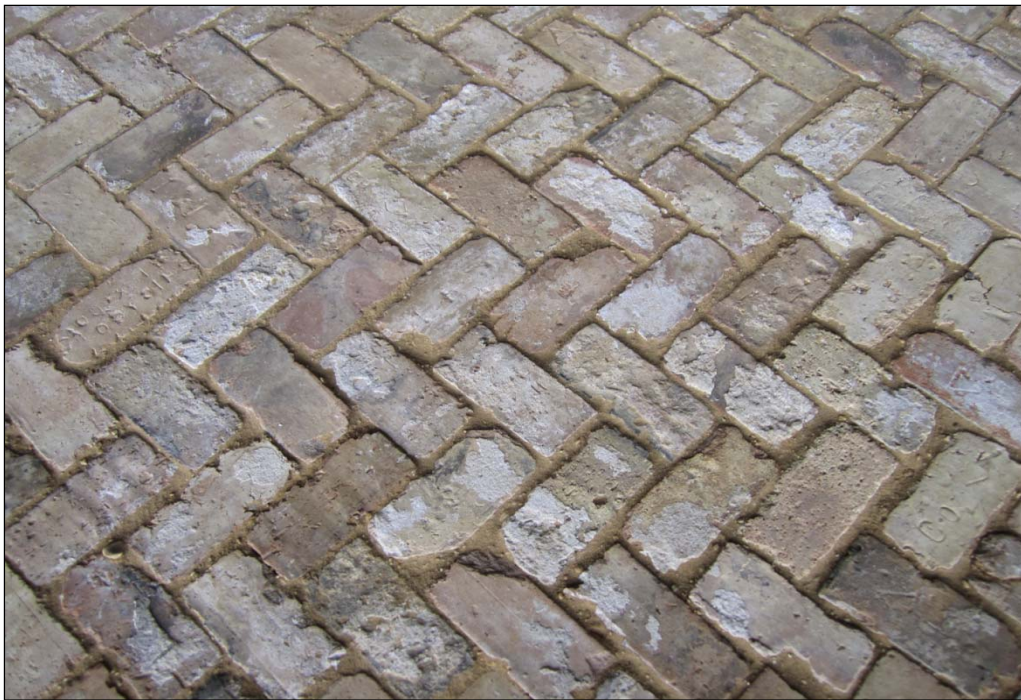
Figure 41. Reclaimed bricks before truck traffic.

Item 2 consisted of recycled bricks. Figure 41 shows the bricks before trafficking. The recycled bricks performed adequately to 10,010 passes without failure. Note that the laboratory tests revealed an average compressive strength of only 3,500 psi and a 44 percent loss in material measured with the LAA tests.

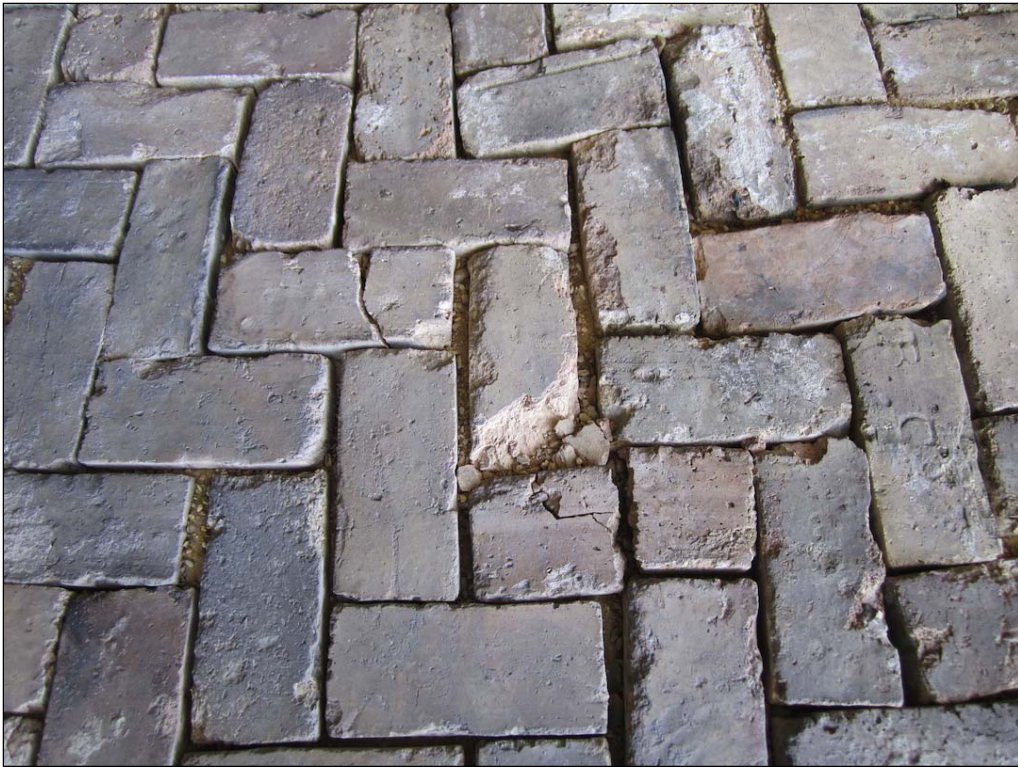
Figure 42. Reclaimed bricks at 5,000 passes of truck traffic.

As was the case for Item 1, there was movement or settlement of the bricks after 10 passes. The bricks began shoving upward around 400 passes, and very few broken bricks were observed beginning around 800 passes. After 5,000 passes, there were more broken bricks and a larger amount of shoved, tilted bricks (Figure 42). Figure 43 shows Item 2 after the completion of truck traffic at 10,010 passes.

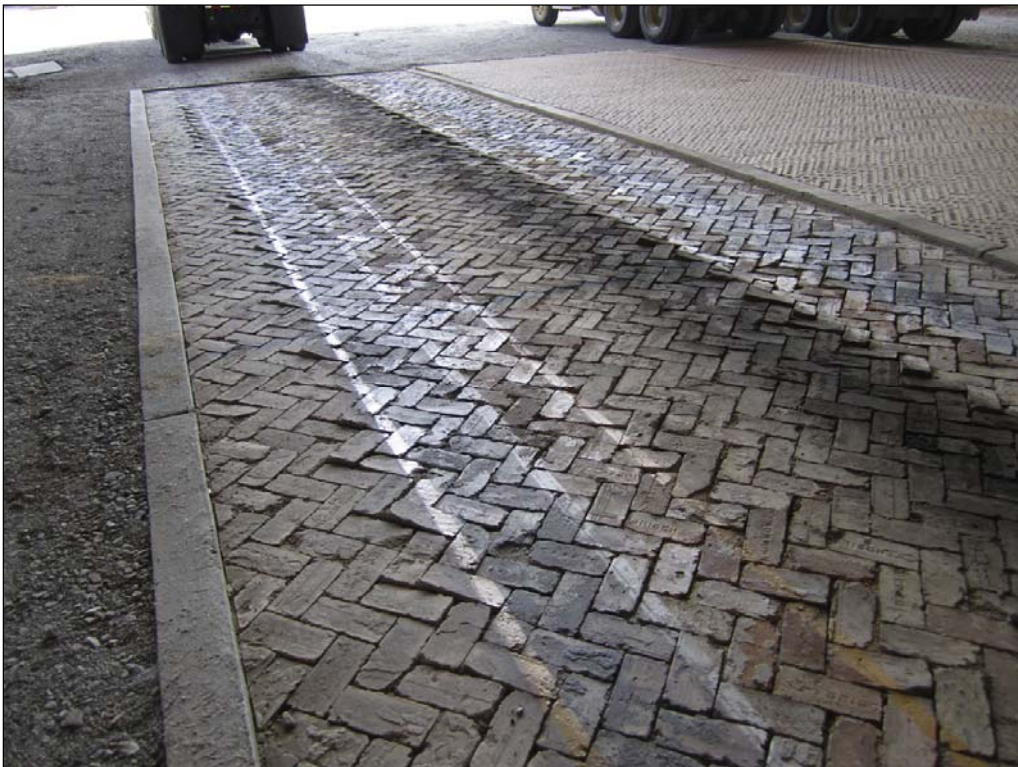
Figure 43. Item 2 at completion of 10,010 passes of truck traffic.

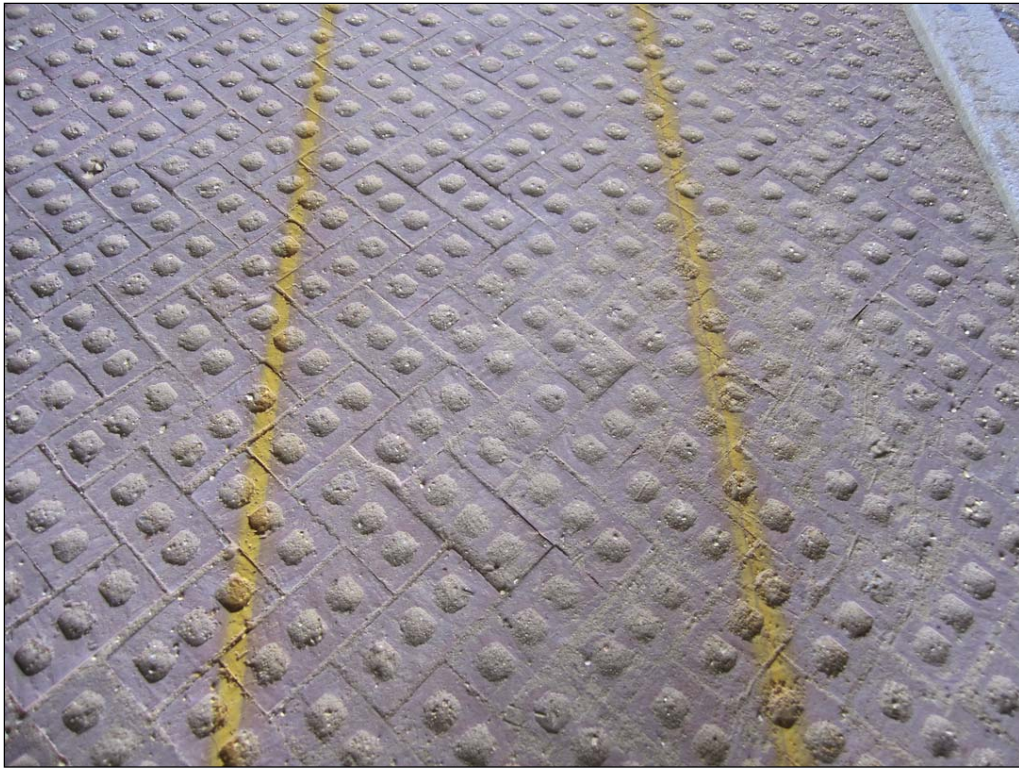
Figure 48. Item 3 wheel path before truck traffic.

Figure 48 shows the bricks in the wheel path before the truck trafficking began. After the 10,010 pass cap, there was only slight upheaval outside of the wheel paths (approximately 0.25 in.). Figure 49 shows the area where the most upheaval was observed following traffic completion. There also were a few broken bricks within the test item beginning with about pass 1,200; most were broken in half.

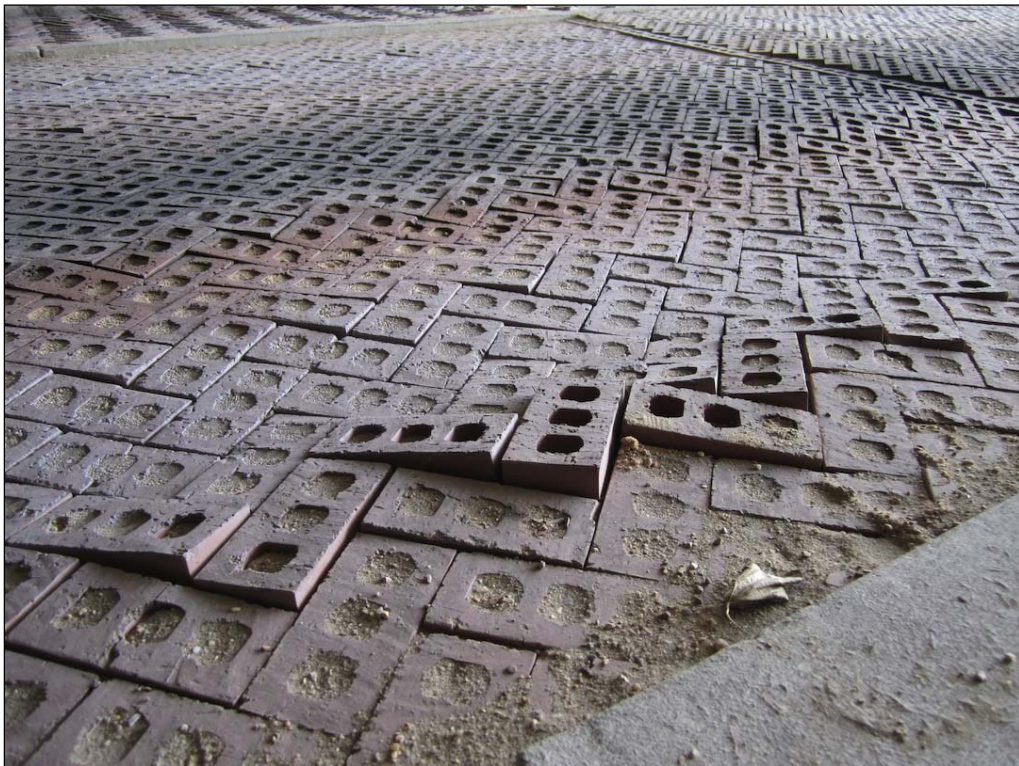
Figure 49. Item 3 wheel path at 10,010 passes of truck traffic.

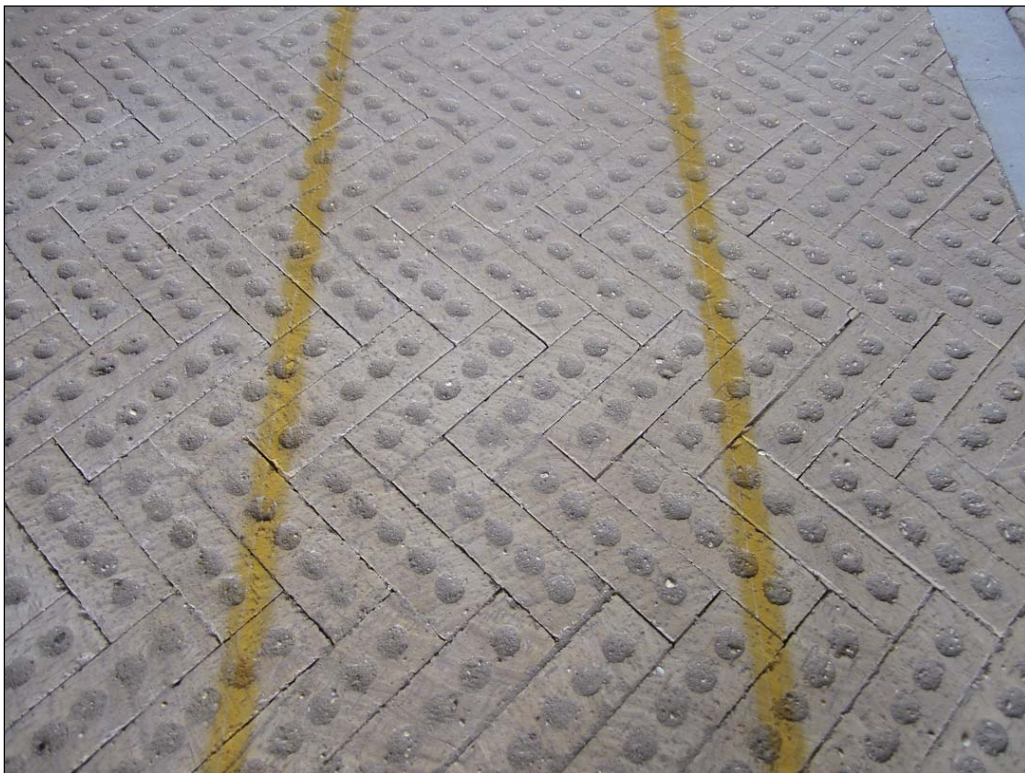
Figure 54. Item 4 utility bricks before truck traffic.

Item 4 consisted of the thicker, wider, and longer utility bricks. Figure 54 shows the utility bricks in the wheel path before the truck traffic began. The average compressive strength determined in the laboratory for the bricks was approximately 10,600 psi. Laboratory LAA tests measured approximately 42 percent loss of material.

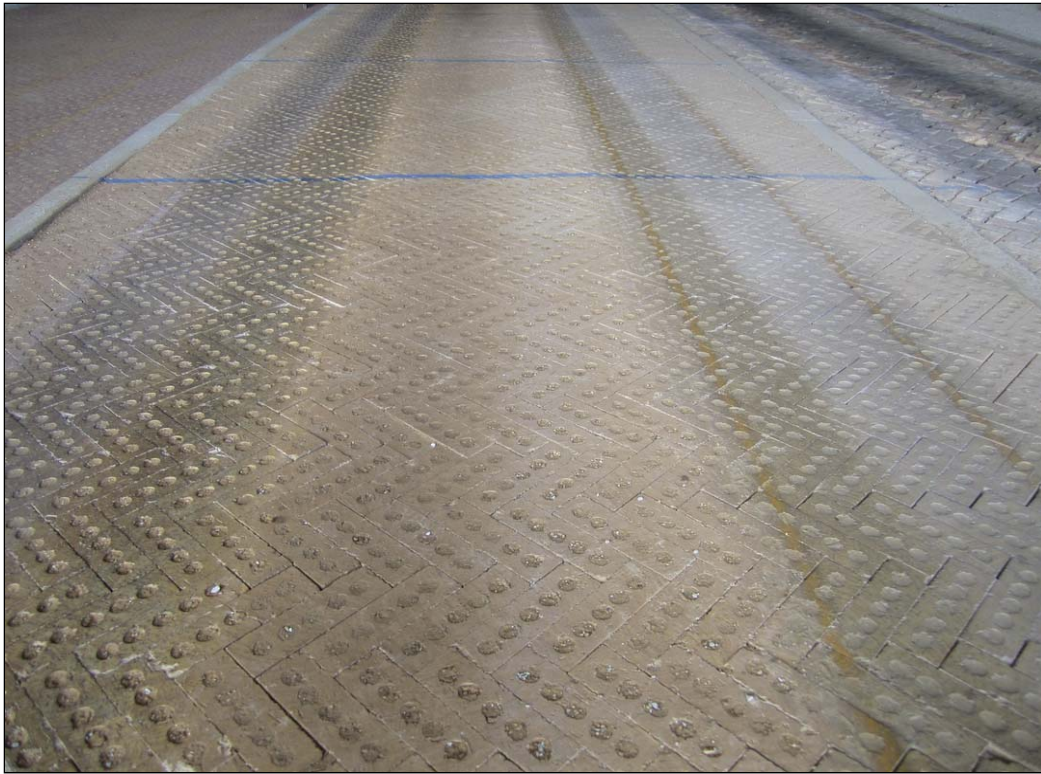
Figure 55. Item 4 overall view at 1,200 passes of truck traffic.

Overall, the utility bricks performed well with little rutting and movement. Traffic was capped at 10,010 passes with an average rut depth of 0.46 in. Figure 55 shows an overall view of Item 4 at 1,200 passes. Chipped and broken corners were observed on some of the utility bricks starting around 1,200 passes. The chipped and broken corners can be seen in Figure 56. Figure 57 shows the bricks after the completion of 10,010 passes of truck traffic.

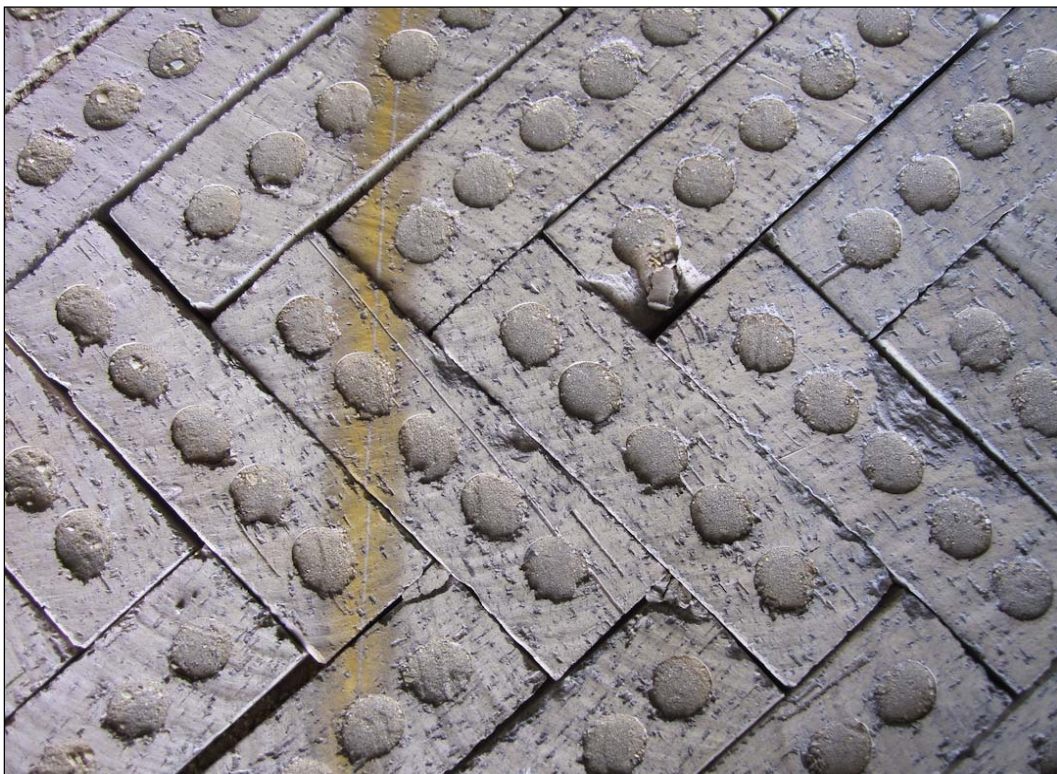
Figure 56. Chipped and broken edges of utility bricks in Item 4 at 1,200 passes of truck traffic.

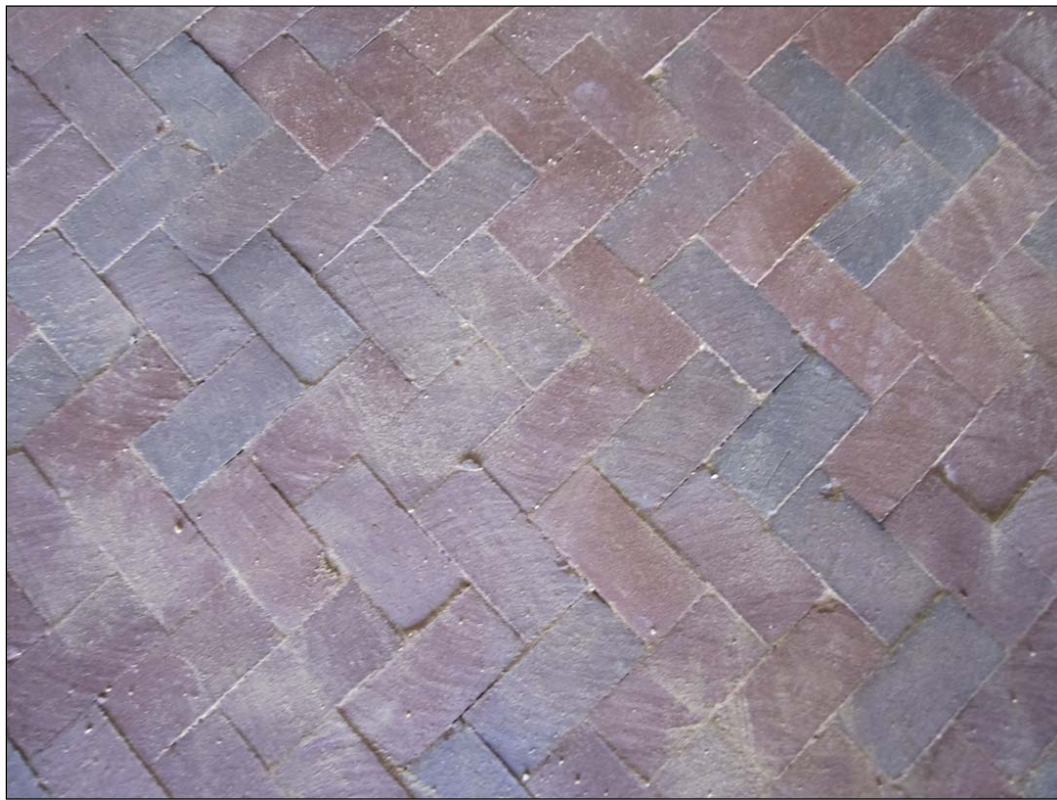
Figure 62. Item 5 brick pavers before truck traffic.

Item 5 consisted of the brick pavers, which were used as the control for the evaluation. Figure 62 shows the brick pavers before trafficking. Note the tight fit of the bricks in the test item. This is due to the brick pavers' uniform shape.

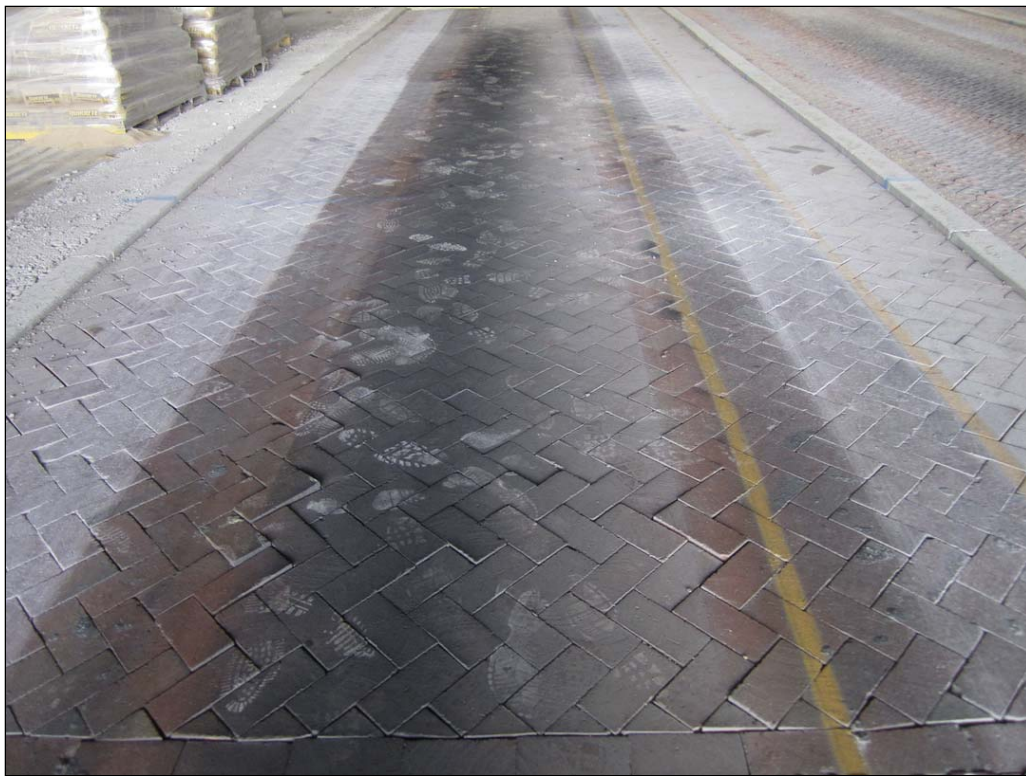
Figure 63. Item 5 overall view at 10,010 passes of truck traffic.

Item 5 was trafficked to 10,010 passes without being close to the 3-in.-deep rut failure point. The brick pavers were observed to begin shifting upward at the corners outside of the wheel paths around 2,400 passes. Almost no brick pavers were broken during the truck trafficking. Figure 63 shows the brick pavers at 10,010 passes.

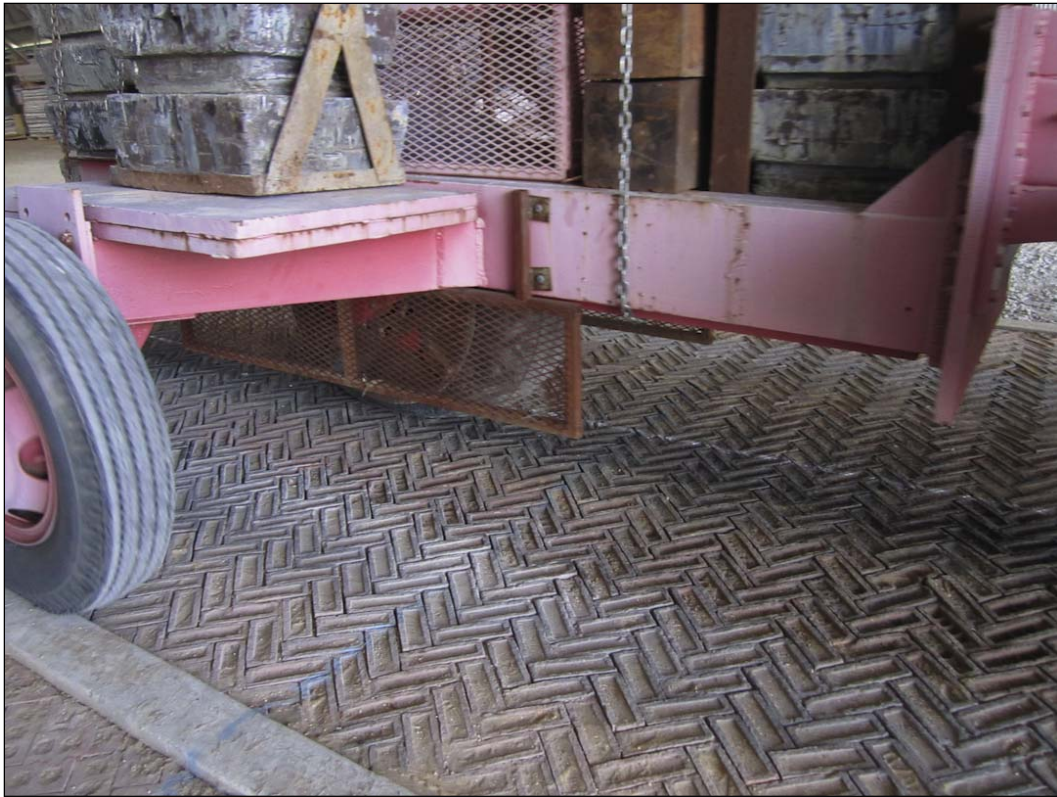
Figure 76. Item 1 during first pass of single-wheel C-17 traffic.

Rutting of Item 1 began almost instantly when the C-17 traffic was applied to the bricks. Figure 78 shows the rut depths measured with increasing traffic. The rut depths were recorded in the center of the wheel path. At 88 passes, the average rut depth was 3.29 in. Failure likely occurred around 25 passes of the single-wheel C-17 load cart traffic.

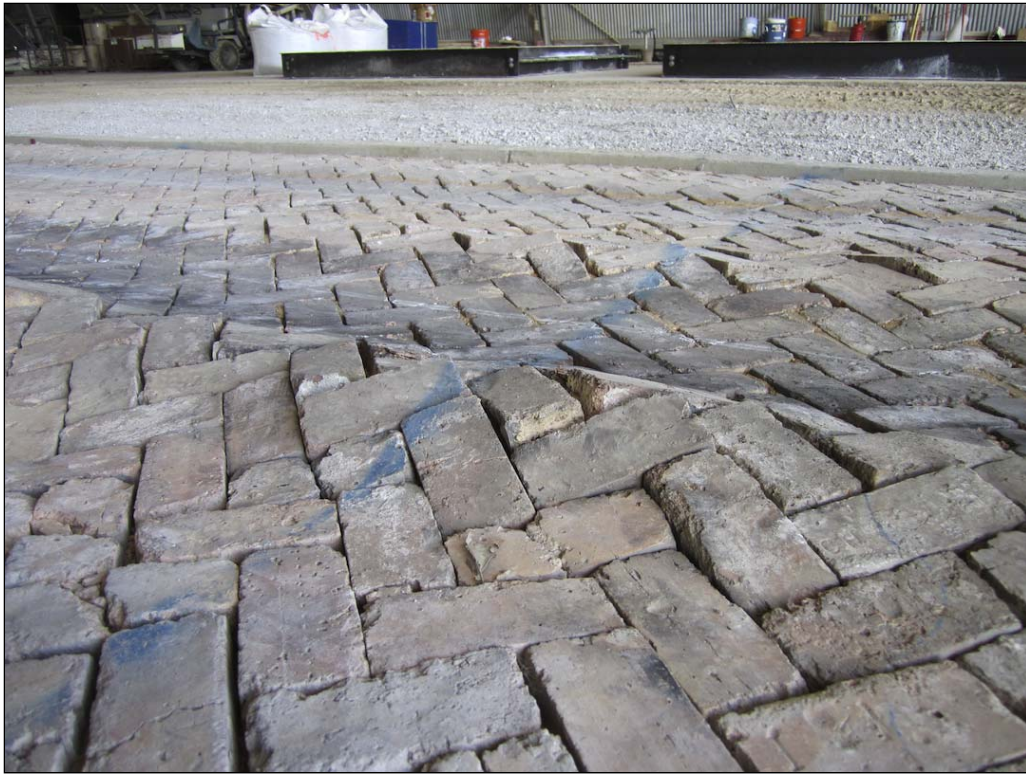
Figure 81. Item 2 at 16 passes of single-wheel C-17 traffic.

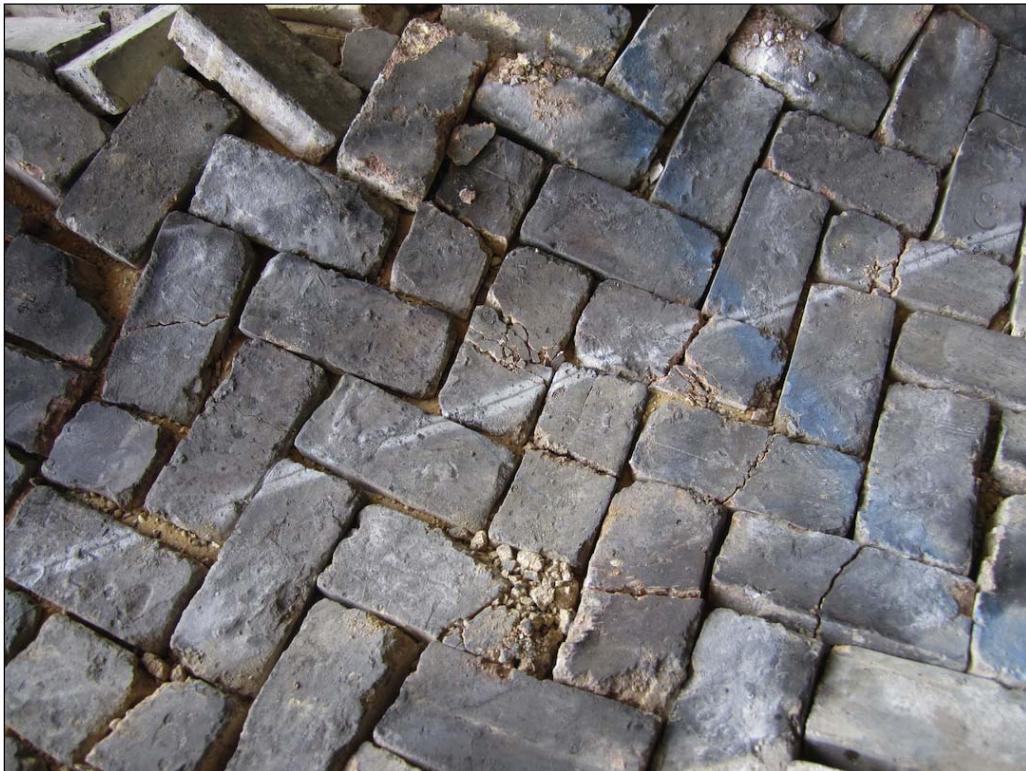
Figure 82. Center of wheel path of Item 2 at 44 passes of C-17 traffic.

Item 2 consisted of the reclaimed bricks. Measureable rutting was observed with the first pass of the C-17 load cart. Traffic was completed at 44 passes with average surface rutting beyond the failure point of 1 in. The reclaimed bricks were not able to handle the C-17 aircraft load. Figure 81 shows the rutting in the test item at 16 passes. Many of the bricks were broken or had crushed corners during trafficking. Figure 82 shows the bricks in the center of the wheel path at 44 passes.

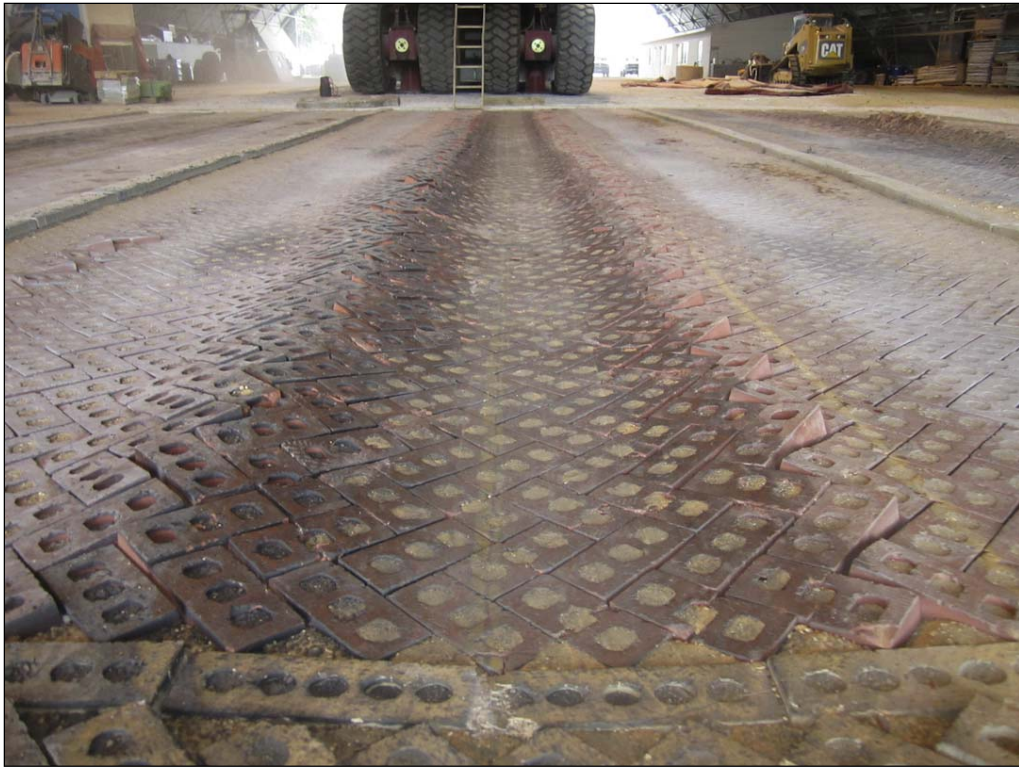
Figure 86. Overall view of Item 3 at 74 passes of C-17 traffic.

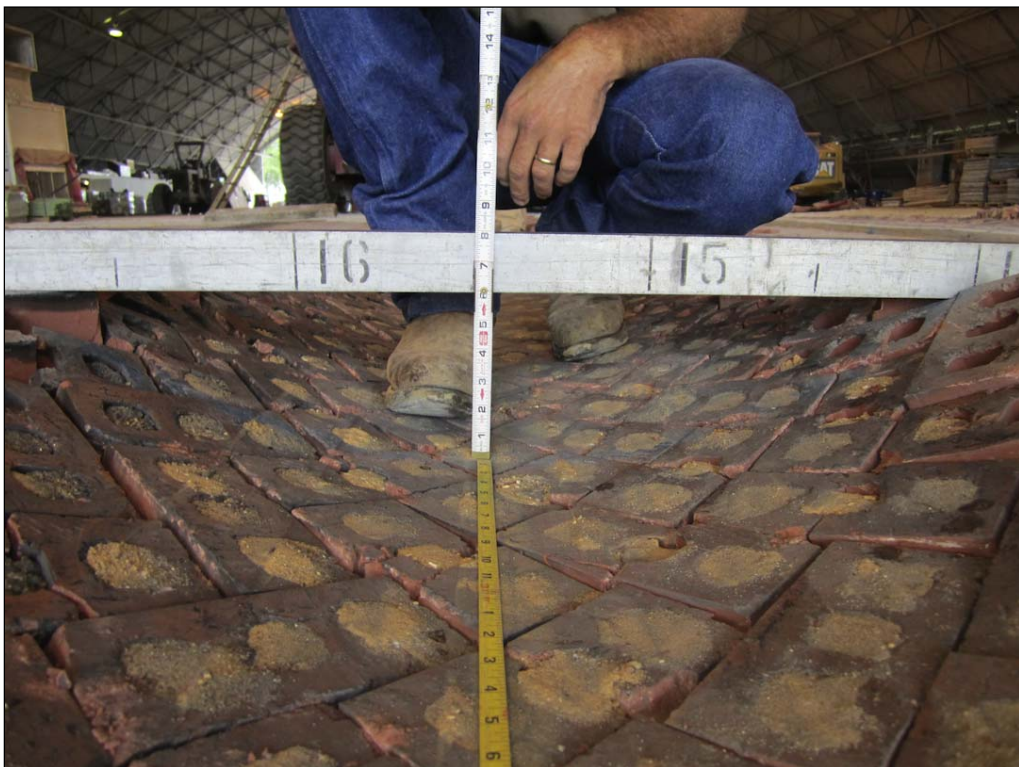
Figure 87. Item 3 rut depth measurement at Station 30 at 74 passes of C-17 traffic.

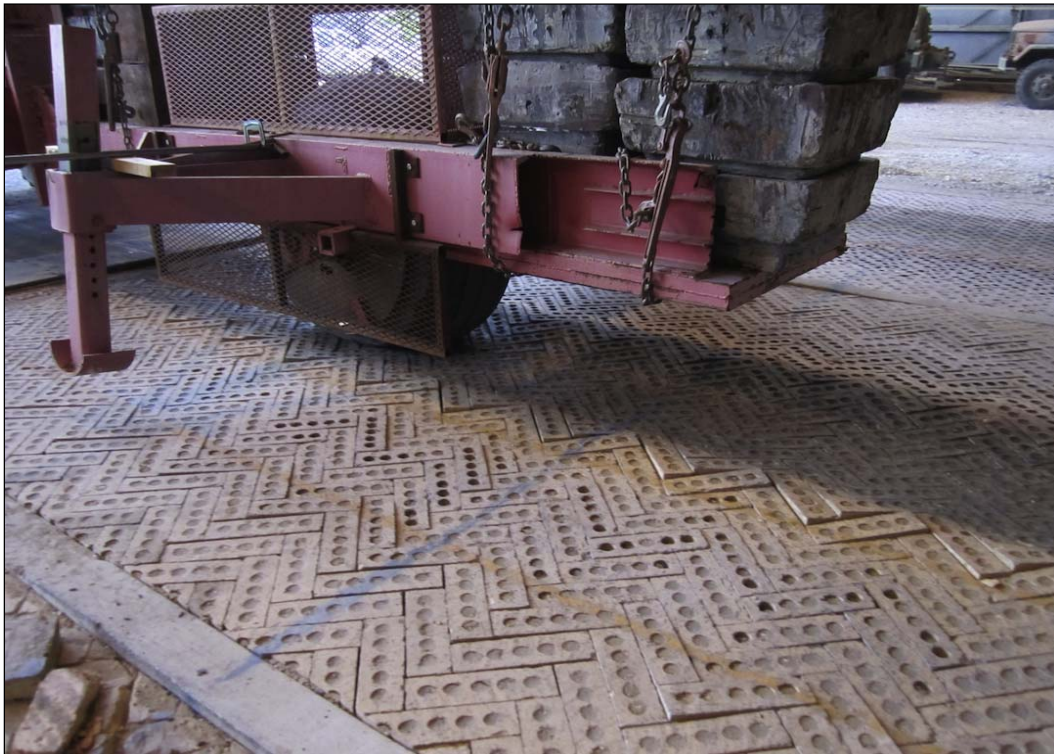
Figure 91. C-17 load cart trafficking near Station 30 at approximately 75 passes on Item 4.

Item 4 was trafficked with the C-17 load cart until 138 passes. The utility bricks were not able to handle the aircraft load without failure. Figure 91 shows the load cart trafficking on Item 4 at approximately 75 passes. There were very few broken bricks during trafficking.

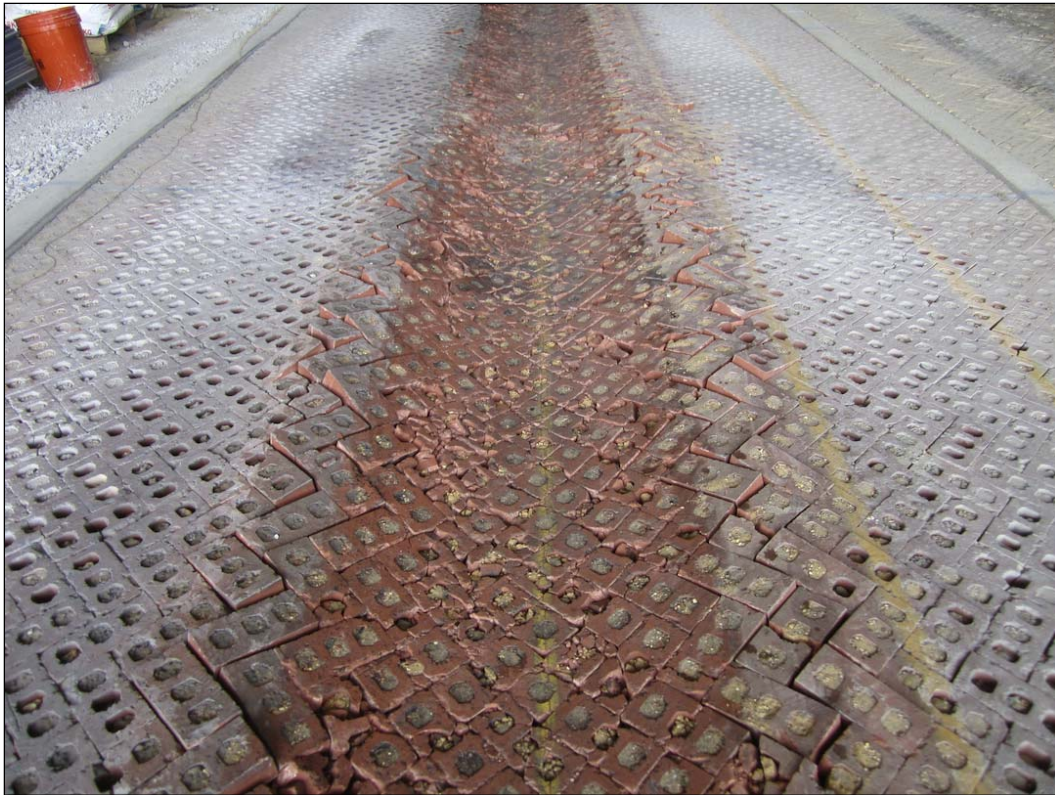
Figure 100. Item 6 overall view at 300 passes of single-wheel C-17 traffic.

Figure 100 shows an overall view of the wheel path at 300 passes. Note the crushed and broken bricks inside the wheel path. Removal of the top layer of bricks after traffic completion revealed the same amount of crushed and broken bricks on the underlying layer of standard modular bricks. The crushed bricks could cause damage to aircraft.

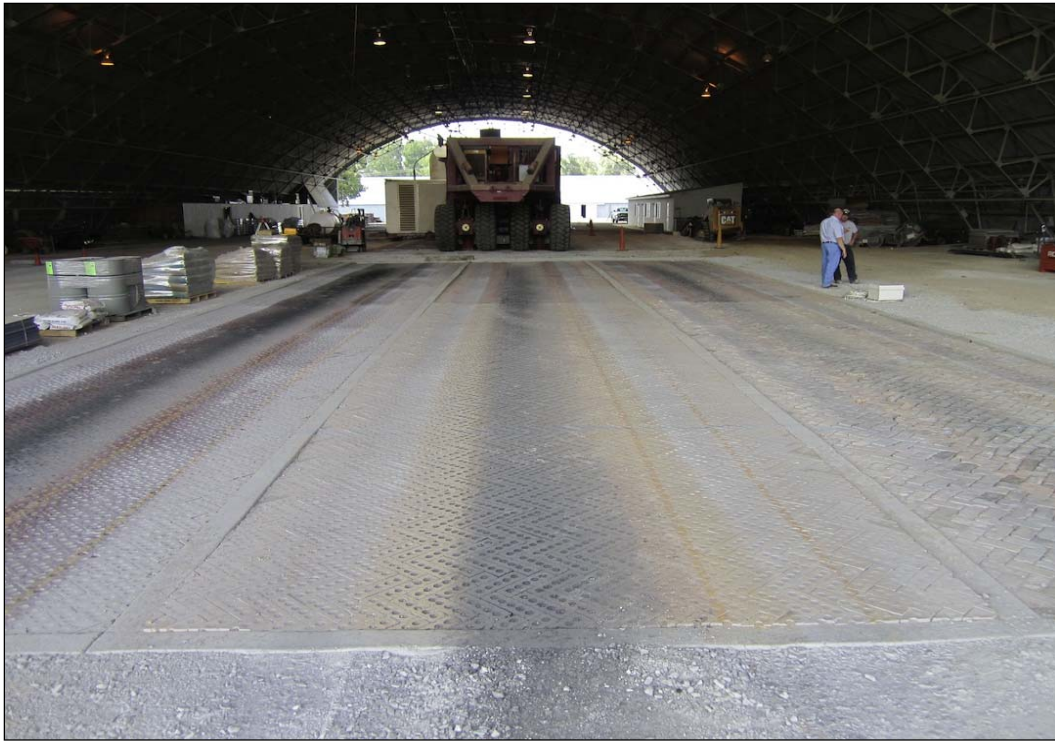
Figure 104. Test section after truck traffic.

Overall, there was little permanent surface deformation after the completion of the truck traffic. Figure 104 shows the test section at the conclusion of all truck traffic. The forensic investigation was conducted to evaluate the pavement structure after the completion of the aircraft traffic, when the most damage occurred. Figure 105 shows an overall view of the test section at the conclusion of the C-17 traffic.

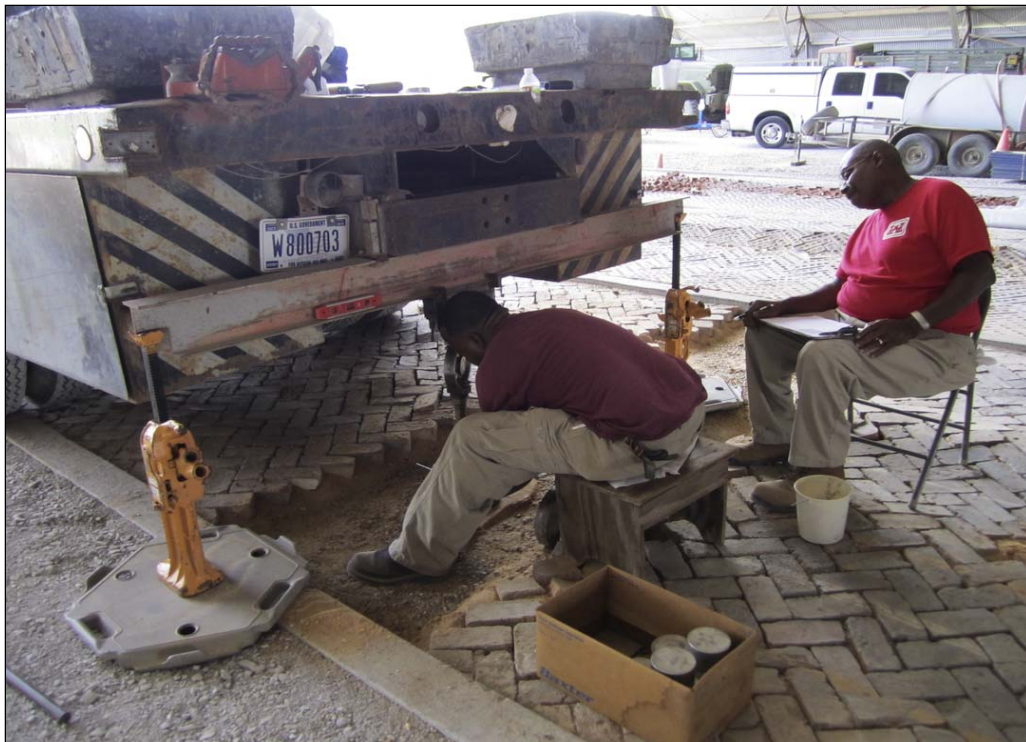
Figure 106. CBR post-testing on Item 2 base course after trafficking.

Table 11 presents the post-test CBRs and oven moisture contents for the base material. For Items 1 through 4, the base strength inside the wheel path of the single-wheel C-17 decreased significantly compared to outside the wheel path. The DCP results on the base material inside the rut compared well with the CBR results inside the rut. Overall, the post-test DCP results in the base material, which were much lower than the pre-test DCP results (80 to 100 CBR post-test truck/pre-test C-17 measurements), likely were due to base course movement caused by the C-17 traffic. The post-test moisture contents of each item were approximately 1 to 1.5 percent lower than the pre-test measurements. The decrease in moisture content was not surprising, as GM material tends to lose moisture over time.
